Number	P.1
Section	Electrical and Instruments
Sheet	1 (of 1)
Date	January, 1960

INSTRUMENTS, OVERDRIVE AND AUTOMATIC  
TRANSMISSION INDICATOR LIGHTS

Mark 2 Models

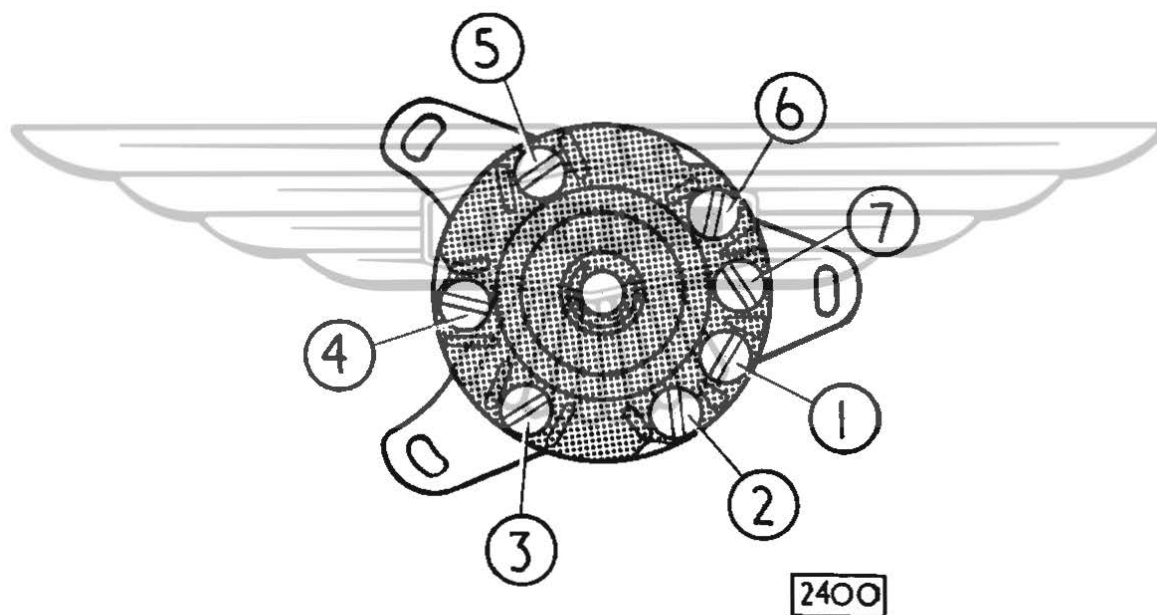
FIG 2

1. -
2. Green (Automatic) yellow/purple (Overdrive)
3. Red/black (Sidelights and taillights)
4. Black/red (Warning light - automatic or overdrive)
5. Brown/white (Ammeter)
6. Red/yellow (Foglamps)
7. Blue (Headlamps)

Replace the cables as shown in Fig.2. and connect the red/yellow cables, incorporated in the harness, to the foglamp terminal.

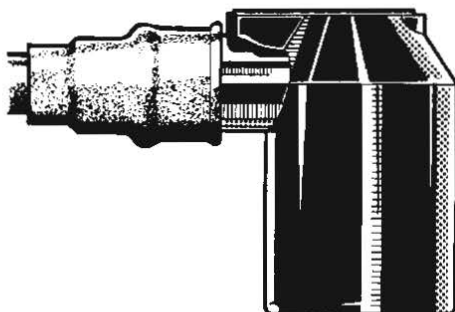
①

Fig.1 shows a sparking plug terminal without a suppressor fitted. Fig.2 shows the sparking plug terminal with suppressor fitted.

Distributors and dealers are requested to examine all cars coming in for service and check if suppressors are fitted. If suppressors are not fitted on cars within the guarantee period these must be fitted on a f.o.c basis to the customer.
